# KEEPING THE LIGHTS ON PERFORMANCE INSURANCE FOR MISSION CRITICAL PUMPS IN A PEAKING POWER PLANT

Recognizing their precarious situation, plant personnel partnered with CIRCOR's authorized service center to conduct a two-week comprehensive teardown, inspection and analysis on one of the two Warren pumps that had been sold new in 1979. The analysis and findings, with recommendations, included:

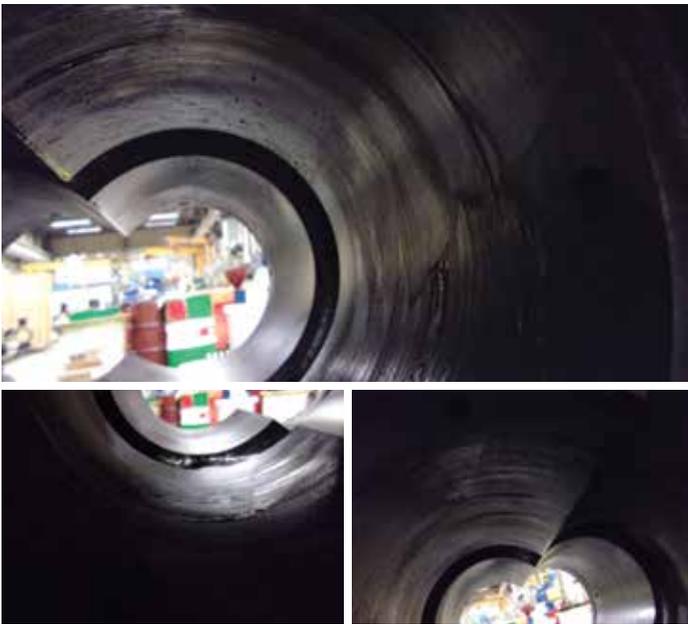
### PUMP CASE

All four bore locations have areas of galling from screw contact in the suction and discharge areas. The bore inside diameters measure up to 0.0085" over the designed high tolerance. This body is cast iron and cannot be restored.

**RECOMMENDATION: REPLACE**

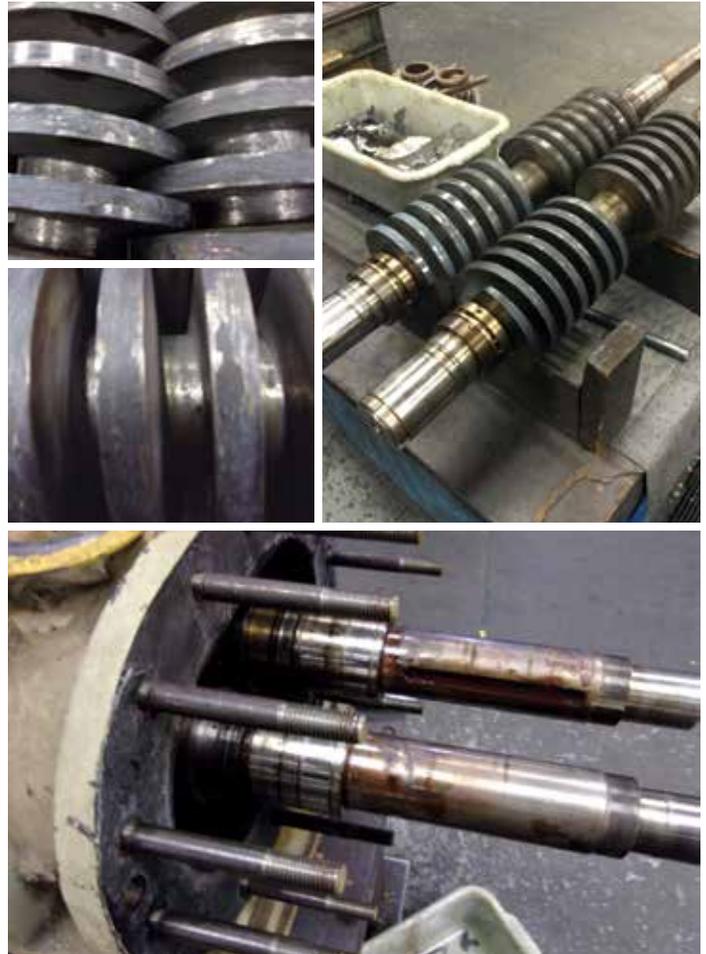
### ROTATING ASSEMBLY

The screw flanks show excessive wear which is indicative of an improper timing of the screw shafts to the gears. Both sides of the flanks show contact. Both long and short shafts have detached coating on the suction and discharge ends of the screw. This matches the heavy contact areas noted above in the casing bores. Outside diameters measure both higher and lower than design depending upon the point of measurement. This is a result of wear as well as raised material on the surface of the screws from flank contact. The flank clearances measure as much as 0.012" which is 0.005" over the high tolerance. This added clearance results in a loss in delivered flow during operation. The timing gears show evidence of heavy fretting, and the inside diameter of the gear bores exceeds designed tolerance.

CIRCOR's bottom line finding was that improper timing of the screws had caused excessive wear to the screw flanks, preventing economical repair of the unit. The turbines operate on light fuel oil viscosity. Assuming a fuel oil viscosity of 44 SSU; the smallest pitch for a 1250 pump (0.875") at the highest rpm (1550); and a differential pressure of 1000 psig (as listed on the nameplate), a new replacement rotating element and reused body would still operate with a volumetric efficiency of only 30%, resulting in excessive pump slippage, inefficiency and heat generation.

**RECOMMENDATION: REPLACE; THE REPAIR PRICE IS MORE THAN 60% THE PRICE OF A NEW PUMP**
