# KEEPING THE LIGHTS ON PERFORMANCE INSURANCE FOR MISSION CRITICAL PUMPS IN A PEAKING POWER PLANT

Recognizing their precarious situation, plant personnel partnered with CIRCOR's authorized service center to conduct a two-week comprehensive teardown, inspection and analysis on one of the two Warren pumps that had been sold new in 1979. The analysis and findings, with recommendations, included:

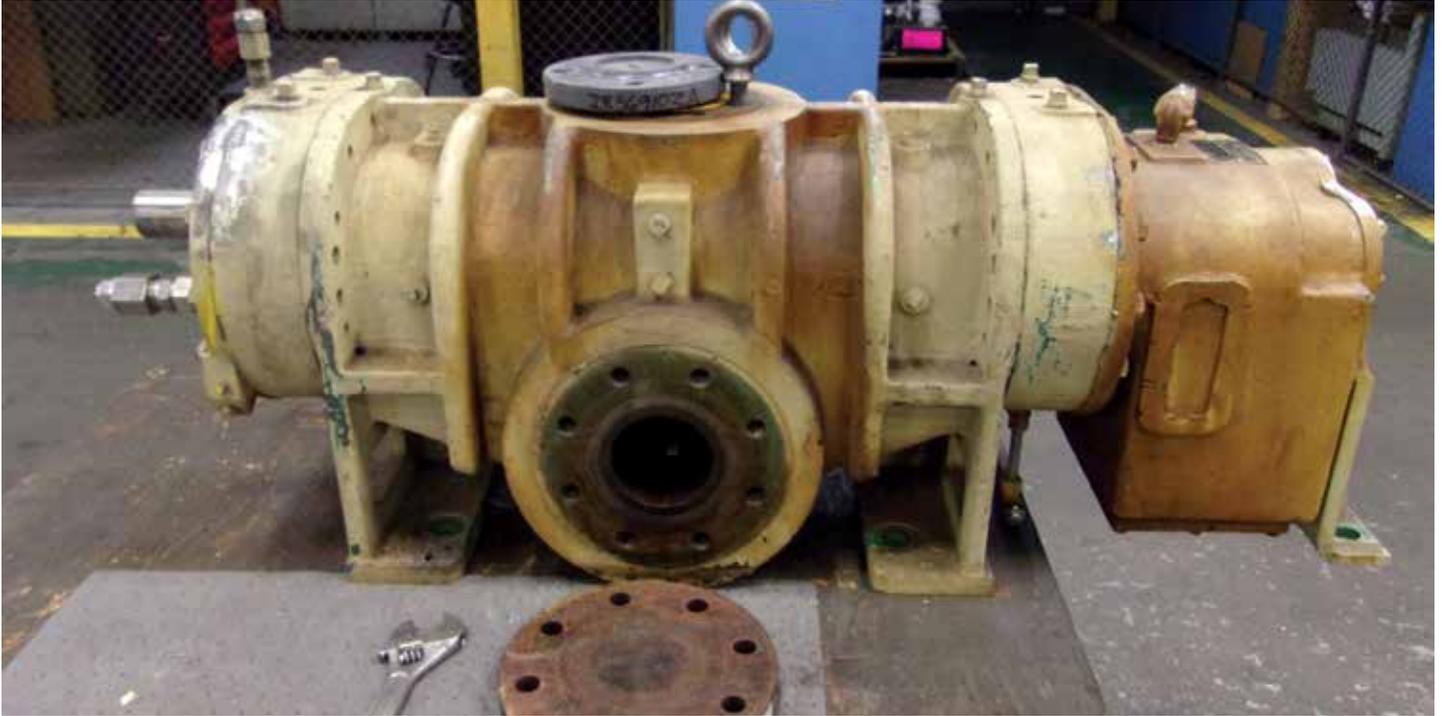
## BEARING BRACKETS

The front and rear bearing brackets require some minor cleaning to thoroughly flush the seal ports. Once this operation is completed these may be used as is. Cleaning and deburring would be required for repair.

**RECOMMENDATION: REUSE**

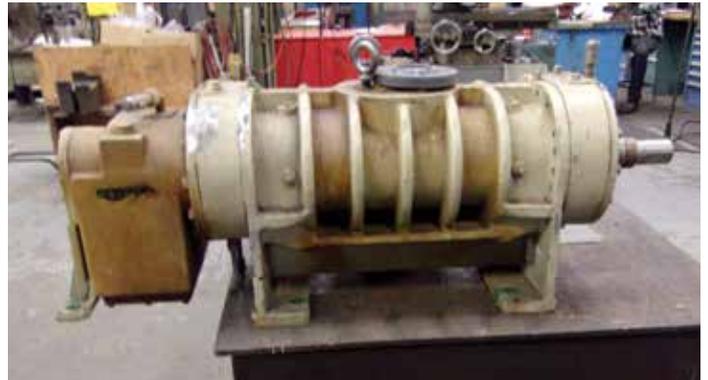
## MISCELLANEOUS PARTS

- › Mechanical seals
- › Bearings
- › Lip seals
- › Gaskets

**RECOMMENDATION: ALL STANDARD PERIODIC REPLACEMENT ITEMS**
